DOT/FAA/CT-94/89

# Corrosion of Fire-Damaged Aircraft

April 1995

Final Report

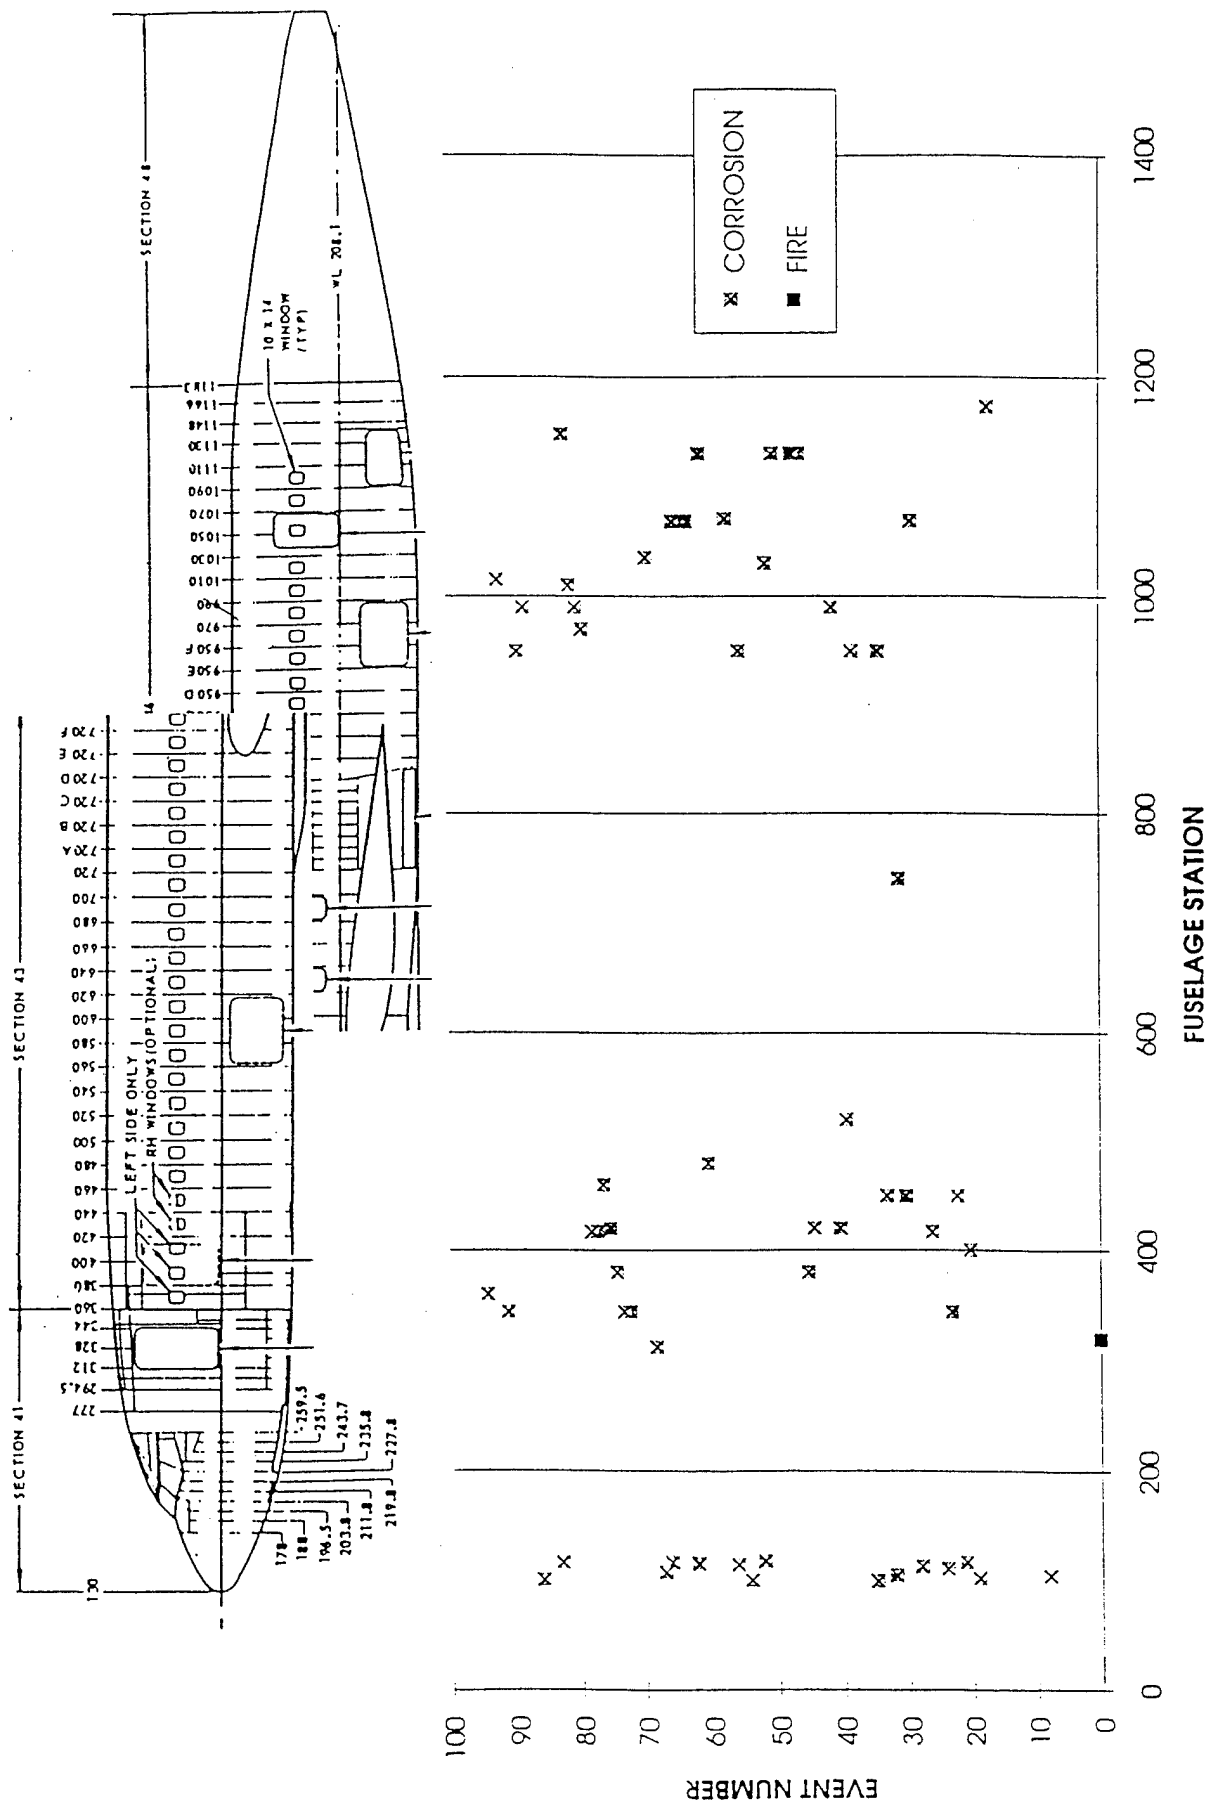
FIGURE 2. B727, S/N 21483: CORROSION AND FIRE SDRs AS A FUNCTION OF FUSELAGE STATION

Mapping of interior fuselage corrosion locations and the fire location are shown in figure 2 for this aircraft. Nineteen corrosion events are shown within 200 inches of the fire. Data contained in the nineteen corrosion reports does not establish a definite relationship between the fire and corrosion. Mapping of corrosion location versus fire location for the other aircraft indicated no concentration of corrosion at or near the fire site.
